Road Surface Rehabilitation

Widoczna Street — Warsaw, Poland

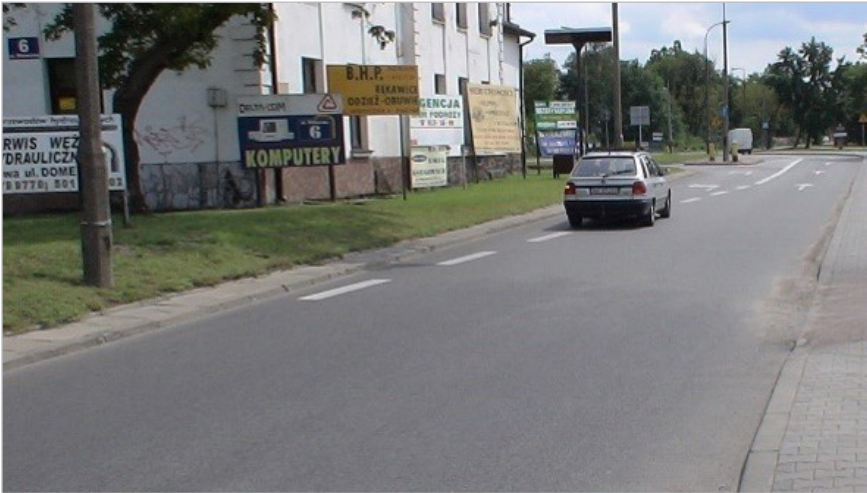
Widoczna Street in the populous city of Warsaw, Poland, was repeatedly being repaved with new layers of asphalt being installed on top of the existing hexagonal paving blocks.

In November 2006, the damaged road surface was milled to a depth of 1½" (4 cm), leaving approximately ¾" (1 cm) of old asphalt on top of the existing hexagonal paving blocks. Simpson Strong-Tie Carbophalt G was then installed on a bitumen tack coat before being covered with a 1½" (4 cm) SMA wearing course.

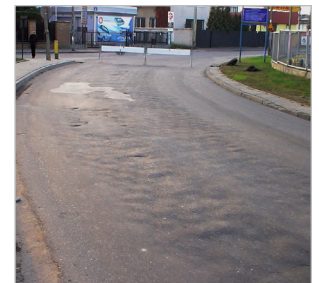
October 2006 — Initial road inspection. Visible damage on the wearing course, where even the pattern from the underlying hexagonal paving blocks can be seen.

Widoczna Street is one of the main thoroughfares through Warsaw, the capital of Poland, which has almost two million residents. As such, it sees a very heavy traffic load that has brought on considerable pavement damage because the asphalt wearing course was placed directly on hexagonal paving blocks. Heavy reflective cracking and deformation surface settlement mirroring the paving blocks necessitated repaving the roadway every three years with new layers of asphalt.

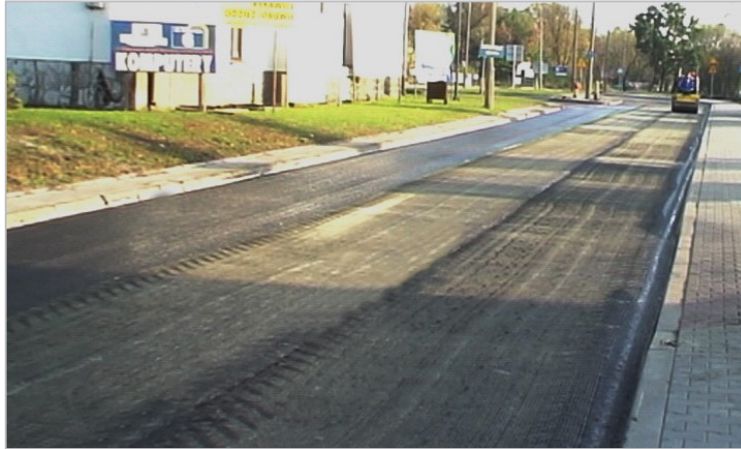
November 2006 — Carbophalt G asphalt reinforcement grid installation onto bitumen tack coat.

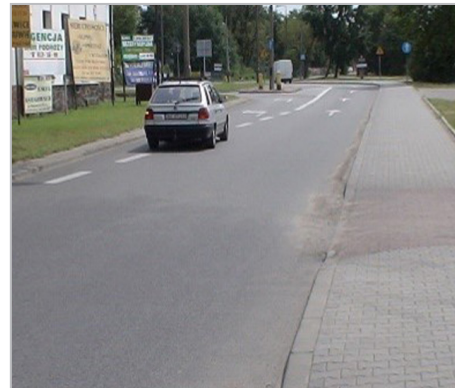
July 2007 — Inspection after eight months. Road remained in great condition.

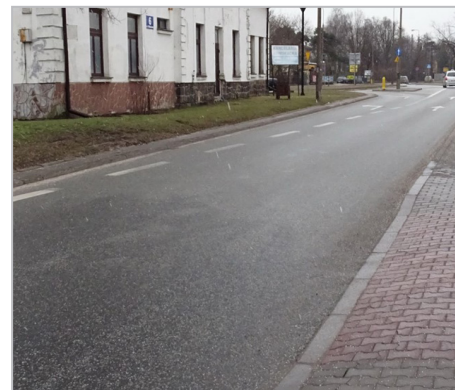
February 2016 — Inspection after 10 years. Nearly 10 years later and still no signs of damage to the wearing course.

To be sure that the grid reinforcement did significantly increase the durability of the wearing course, Simpson Strong-Tie regularly tracked the road condition of Widoczna Street over the next several years. Results met expectations and more. The observed results exceeded the owner's expectations; after a full decade the road remained in superb condition with no signs of damage to the wearing course.
