Road Surface Rehabilitation

Service Station — Parsberg, Germany

A3 Parsberg Service Station
Parsberg, Germany

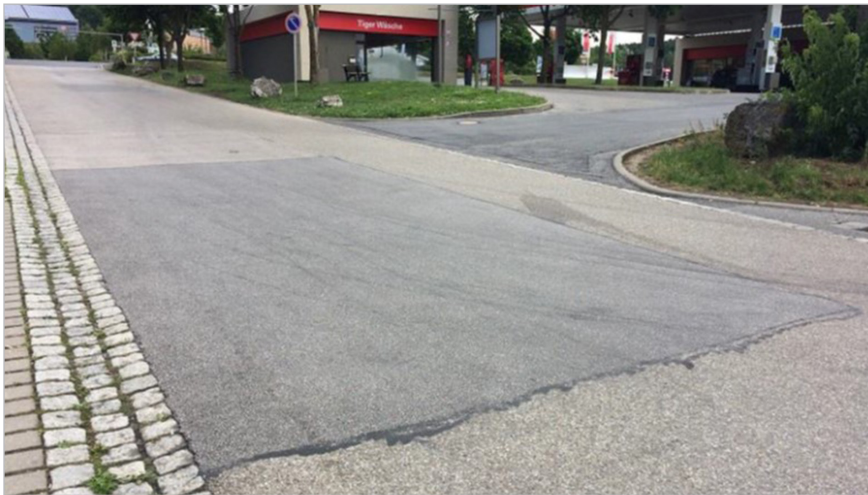
Service station access road

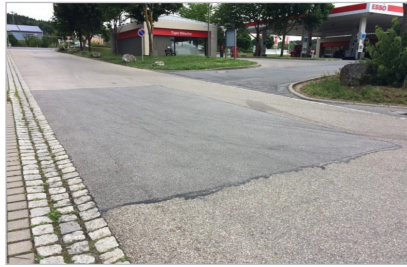
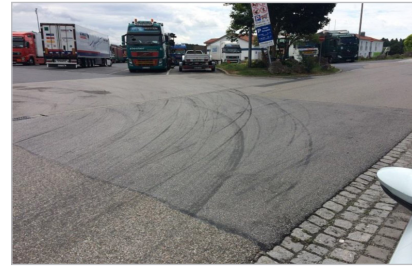
Condition in 2017 — six years after installation

The solution using Carbophalt G reinforcement grids performed admirably despite the road grade and continuing traffic conditions. For more than six years after the resurfacing, no damage or cracking was observed on the repaired sections of the access road. In fact, it wasn't until 2020, nine years after installation, that the first signs of deterioration began to appear in the form of incipient top-down cracking — but these were not of an extent to call into question the serviceability of the repaired surface. Compared to the repair record of the pavement prior to the reinforcements, the service life had been increased at least ninefold with the help of Simpson Strong-Tie Carbophalt G asphalt pavement reinforcement grids.

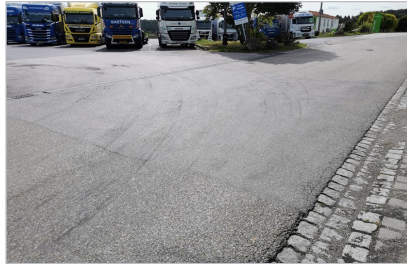
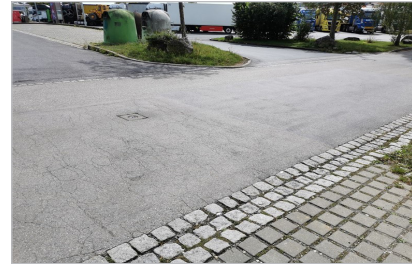
Condition in 2020 — nine years after installation

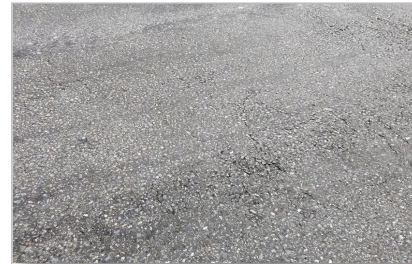
Condition in 2020 — first signs of deterioration after nine years; damage is not considered significant enough for the road to be repaired yet
