U.S. Army Corps of Engineers restores eroding fish passage with help from Simpson Strong-Tie

Mill Creek Division Works Fish Ladder, Corbel Upgrades and Pier Rehabilitation

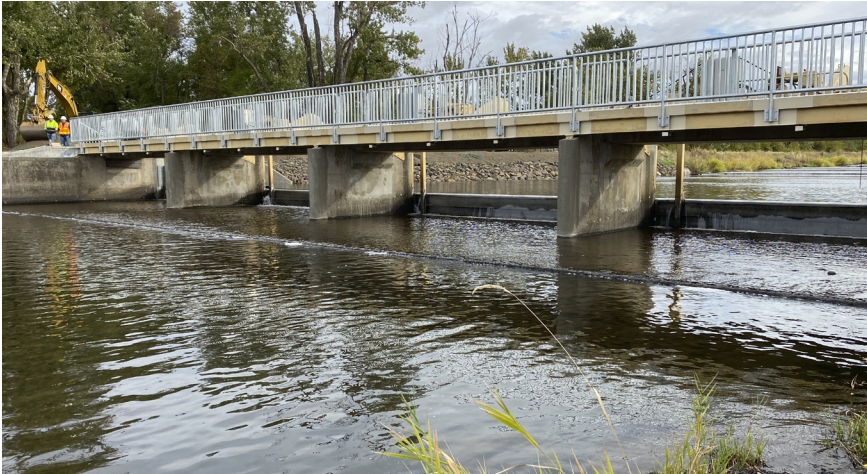
Completed project with damaged sections repaired, strengthened, protected and seamlessly blending with the original design.

When the work was done, the FRP design had restored both the corbels and the piers to their original structural integrity while simultaneously helping protect them from further deterioration, in effect giving the structure a second lease on life.

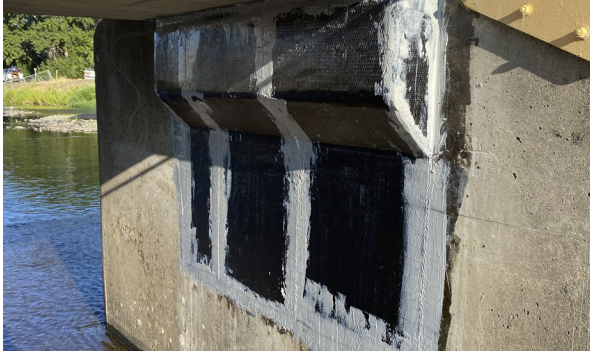
CSS-CUCF11 carbon FRP was installed over the repaired corbel to extend the life of the structure and assist in preventing future deterioration.

Simpson Strong-Tie engineering services proposed an RPS mortar solution to rebuild the eroding corbels, followed by application of CSS-CUCF11 code-listed unidirectional carbon fabric for strengthening. The contractor liked the design, and the Army Corps of Engineers approved it as well. Simpson also worked extensively with the teams to provide installation training and technical advice as installations were completed.

Repair work began in July 2020. First, Simpson Strong-Tie RPS-406 zinc-rich primer was applied to the exposed steel reinforcement bar to protect it from corrosion. Crack injection was done here with CI-LV prior to any mortar repairs. Next, alternating layers of RPS-752 epoxy bonding agent and RPS-263 rapid-hardening vertical/overhead repair mortar were used to rebuild the deteriorated corbels to their original size. Finally, the repaired corbels were strengthened with applications of CSS-CUCF11 carbon fabric. On-site samples were created and tested offsite. Test values for the layers of mortar in the vertical repairs were very high, showing excellent adhesion, as were those for the FRP applications.

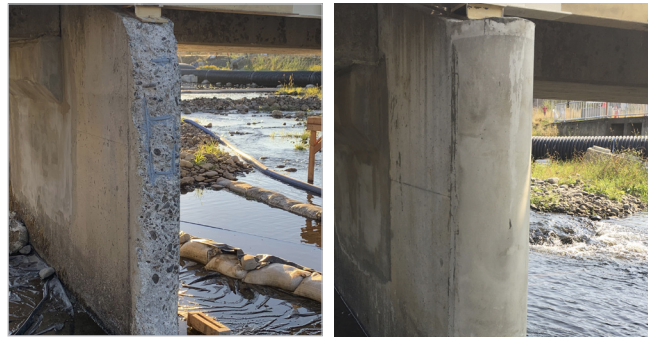
The contractor fabricated custom forms to enable access to the repair area for application of the RPS-752 bonding agent and speedy pour of RPS-263 rapid-hardening repair mortar.
