Road Surface Rehabilitation

Grabiszyńska Street — Wrocław, Poland

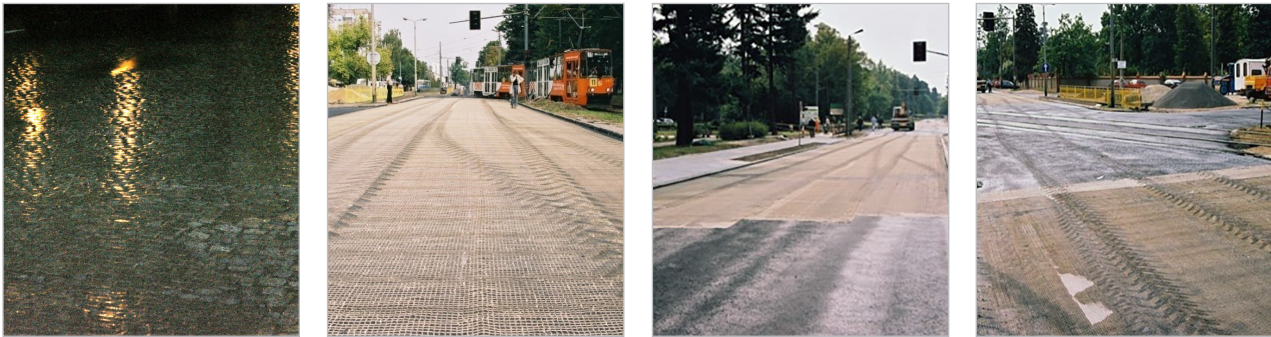
September 2003 — Simpson Strong-Tie asphalt reinforcement grid installation. *The city of Wroclaw decided to repave the cobblestone road to ensure a more comfortable drive for road users.*

On Simpson Strong-Tie's recommendation, the road owner decided to reinforce the braking and stopping zones in front of the traffic lights with Simpson Strong-Tie Carbophalt™ G asphalt reinforcement grid. The grid was installed in these specific locations in order to counteract the shear forces and point loads introduced into the thin asphalt layer by decelerating, stopping and accelerating traffic. The high-tensile carbon fibers in Carbophalt G are particularly suitable for this purpose, as they are capable of absorbing considerable forces even at the lowest elongations (> 1.5%) and anchoring them in the bond with the surrounding asphalt.

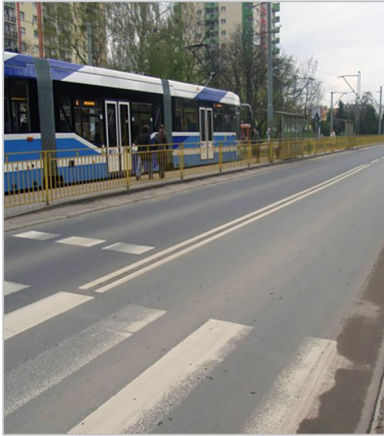
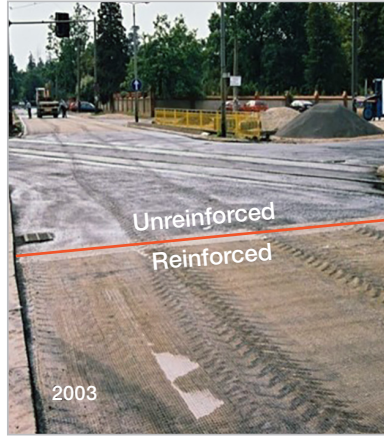
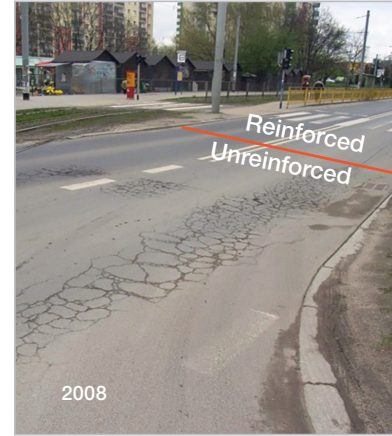
April 2008 — Inspection after 4.5 years. In the areas where Carbophalt G was installed, no damage was observed — in sharp contrast to sections of road with no grid.

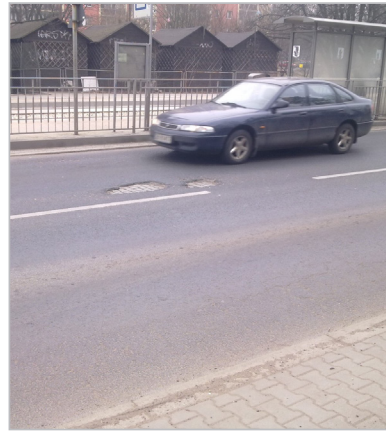
November 2009 — Inspection after 6 years. Even after six years, the road sections where Carbophalt G asphalt reinforcement grid was installed remained in great condition.

November 2011 — Inspection after 8 years. Finally, after eight years, the first signs of damage appear, in limited and isolated locations.

The asphalt overlays reinforced with Carbophalt G achieved a service life that exceeded that of the unreinforced overlays by at least a factor of three despite the increased loads and requirements in the intersection areas. It was not until 2011, eight years after construction, that the first damage to the reinforced areas became visible.
