Heli-Tie™ Helical Ties Stitch and Stabilize Unreinforced Masonry Walls at Quebec Pulp and Paper Mill

Rayonier Advanced Materials Pulp and Paper Mill in Temiscaming, Quebec

Repairing and stabilizing unreinforced masonry (URM) walls

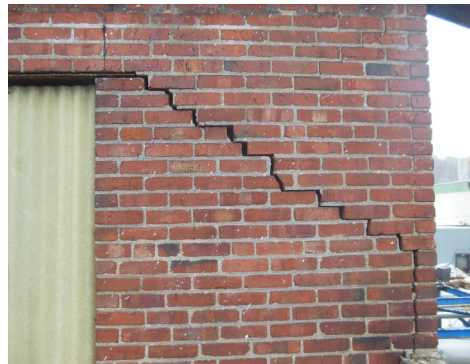
Recently, it became clear that Rayonier's hundred-year-old pulp and paper mill in Temiscaming, Quebec, was deteriorating. Vertical cracks were opening in parts of the masonry, and some URM walls showed signs of destabilization. Specifically, at least one of the unreinforced, multiwythe brick walls of the digester building displayed growing separation between its wythes.

Unreinforced, multiwythe brick wall displayed significant cracking in need of repair.

Use Simpson Strong-Tie Heli-Tie wall and stitching ties to restore wall integrity and repair cracks, respectively.

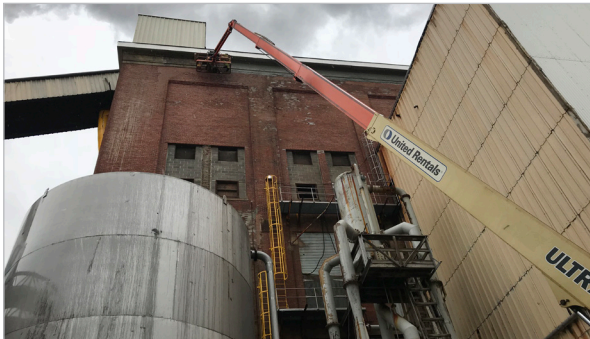
Installation of Heli-Tie™ ties required using a lift to reach heights of almost 120'

Rayonier's in-house engineer determined that the wythes could be adequately braced using Simpson Strong-Tie® Heli-Tie helical ties. Various lengths of the Heli-Tie would be required as a result of the inconsistency in brick wall thicknesses. Thicknesses ranged from two to four wythes in a single wall. Some of the walls on the building also reached 120' in height and 260' in length — all of which contributed to the scope and challenge of the project.

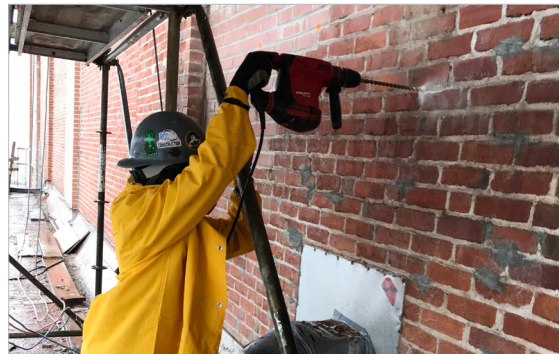
Drilling holes for installation of Heli-Tie wall ties.

First, the multiwythe brick walls were stabilized by installing Heli-Tie helical wall ties spaced in the mortar joints every two bricks horizontally by every five bricks vertically, which corresponded to 17" o.c. horizontally by 12" o.c. vertically. This was done to tie the wythes together so as to mitigate their further separation.

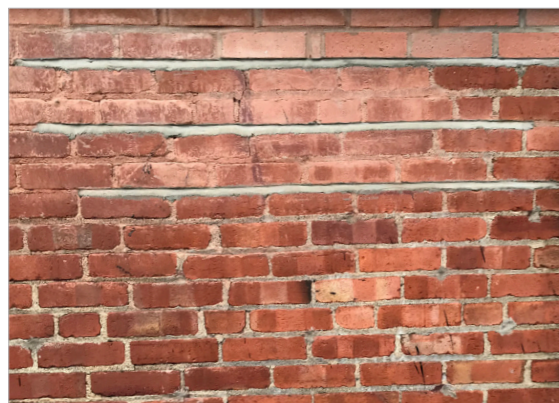
Repointed mortar on the face of the URM wall at Heli-Tie installation locations.

URM walls were repointed at the Heli-Tie insertions to prevent moisture intrusion. Although the Heli-Tie wall ties are available in both Type 304 and Type 316 stainless steel, repointing is encouraged to prevent moisture intrusion and corrosion of rebar, where it may be present.
