# FRP solution helps with quick resuscitation of Anchorage YMCA after earthquake damage

Anchorage YMCA

Repairing and reinforcing earthquake-damaged exterior CMU walls

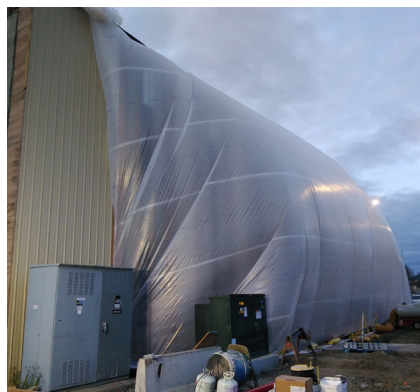
A heated tent was created on the exterior of the gym for FRP installation in Alaska in November.

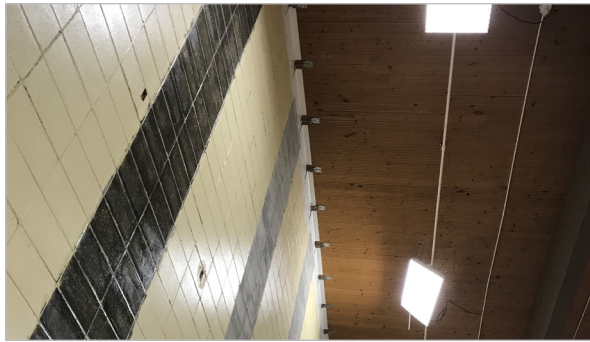
The wall was moved back into plane, and connectors were placed at the top of the wall.

After the walls were repositioned vertically and anchored in place, the next step was to repair and reinforce the CMU where it was cracked. Utilizing a fiber-reinforced polymer (FRP) retrofit solution made sense from both a strength and an expense standpoint. Since the reinforcement was to be installed on the outside of the building, a low-profile solution was also preferable.

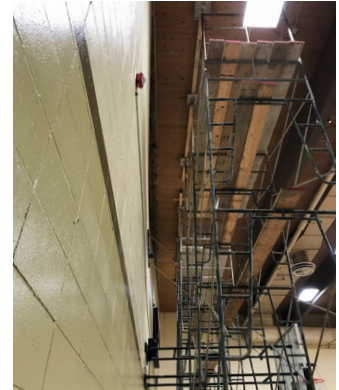
Plane deflection of the wall at the roofline, showing how critical the damage was.

The extent of the damage to the gymnasium walls meant that the walls first had to be moved back in plane and anchored there before the CMU could be repaired and reinforced. Cracks ran through both the interior and exterior faces of the walls, so the retrofit solution had to be applied to both surfaces of the wall. As an added challenge, because the FRP work was taking place in Alaska in November, contractors had to tent and heat the building's exterior walls before and during installation and for the entire cure time.

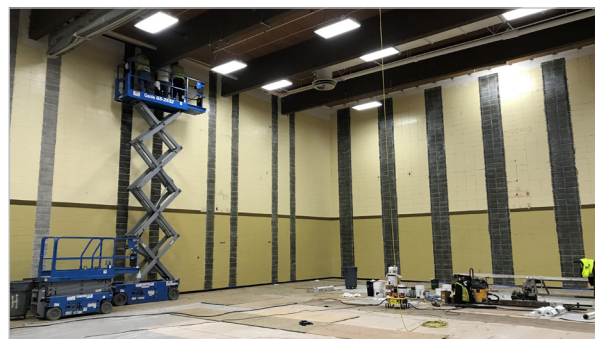
Interior view of FRP installation in progress, showing the vertical strips and spacing needed to retrofit the gym.

It was determined that the strengthening solution would consist of applications of Simpson Strong-Tie CSS-CUGF27 code-listed unidirectional E-glass fabric, bonded with CSS-ES saturant resin, to both the inside and outside faces of the walls.
