Fiber-reinforced polymer (FRP) solution helps keep college students in class during building retrofit

BACKGROUND Forty-five-year-old community college building required a seismic retrofit to its concrete roof diaphragm

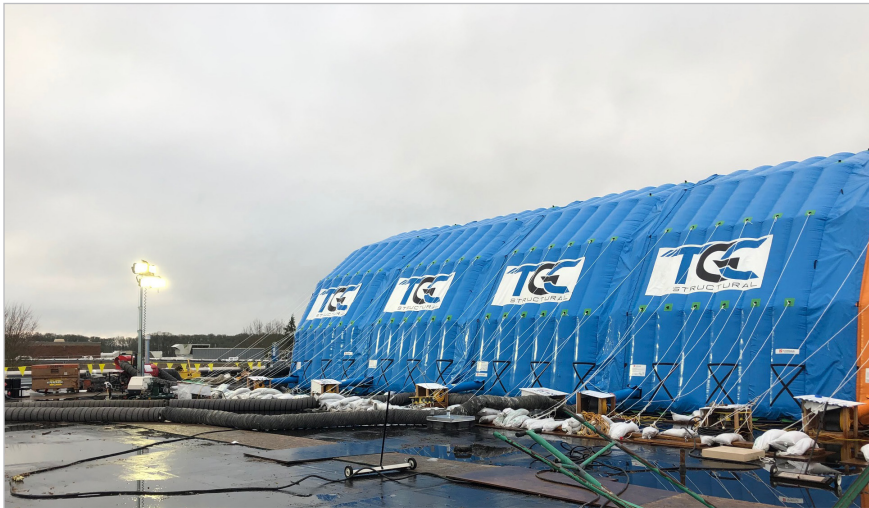
Exterior view of the tenting required to install the FRP at proper temperatures in winter conditions.

To retrofit the diaphragm, the installers needed to remove the roofing and waterproof membrane, roughen the concrete to be strengthened, apply the FRP, and then reinstall the roofing. In order to keep the FRP above the required minimum temperature for installation — a challenge in Oregon in mid-winter — tenting and heating were required. Plus, the area to be reinforced was so large that the tenting needed to be moved sequentially among five separate segments or “zones” of the building — presenting an additional logistical challenge for the first-time FRP installers.

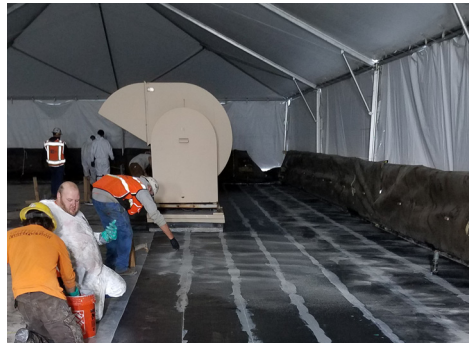
Workers installing FRP strips as in-plane shear reinforcement to the concrete roof diaphragm.

The strengthening solution consisted of applying FRP strips at 45° angles to each other across the joints between the diaphragm slab and the perimeter beams; applying FRP reinforcement strips along edges of slab penetrations to transfer loads around the openings; and applying FRP strips orthogonally along the length and width of diaphragm surfaces for in-plane shear reinforcement in both directions.

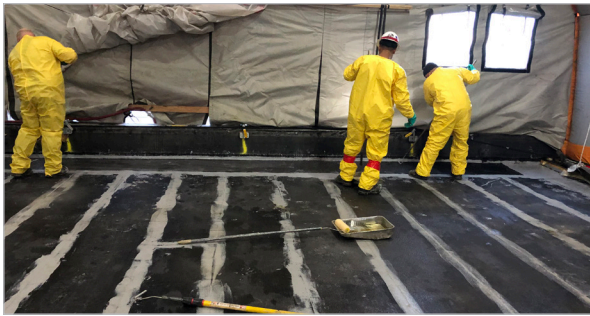
Workers applying a second, perpendicular, layer of in-plane diaphragm reinforcement over the initial layer.
